**Flood Control Project Maintenance
Levee Inspections**

Fall 2019 Levee Maintenance Deficiency Summary Report

Sacramento River Basin

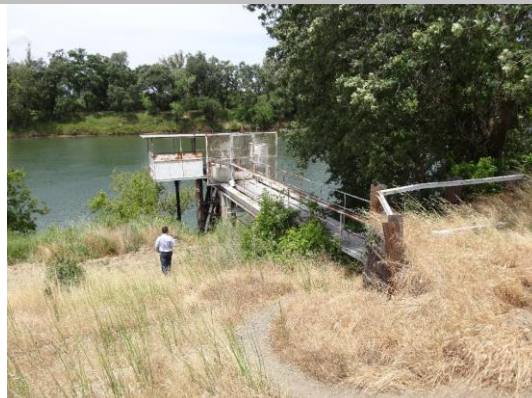
Photo 1 of 3 : UCIP_FA_2019_55172_24060.jpg

Comment Code					
Inspector Comment					
DS_ID:22587 FS_ID:55172 EP_NO: 3903 Repair Type: Urgent Crossing Status: Found UCIP Comments: 08/21/2019 Crossing has been updated from No Action Needed to Urgent, leaky pipe visible on LS. Open cut on LS visible from LS shoulder. Owner is coordinating with CVFPB on emergency repair. Pipe has failed and is no longer in use. Refer to CVFPB Enf ID 15536 for further coordination details. (O. Magana - DWR UCIP)08/14/2019 Pipe is under enforcement action and pipe is expected to be replaced under emergency repair. Contact Alex Acosta with CVFPB for updates. (O. Magana - DWR UCIP) 05/16/2013 - working during field survey- found steel standpipe instead of concrete standpipe.- siphon breaker on the waterward side not found. (P. Amatya - DWR UCIP) FIELD_STRUCT_DESC: 20-inch welded steel irrigation discharge pipe through the levee, 8.2 feet below the crown. 16-inch propeller pump and platform on the riverbank. Pressure breakers on the landside (LS) corrugated metal pipe (CMP) riser. Pipe discharges into a steel standpipe in the LS toe. (20-inch steel irrigation discharge pipe and 16-inch propeller pump authorized under Permit No. 3903, 1962 - White Oak Ranch). FS Date: 8/21/2019 1:07:00 PM

WS- pump station on steel structure on river bank.

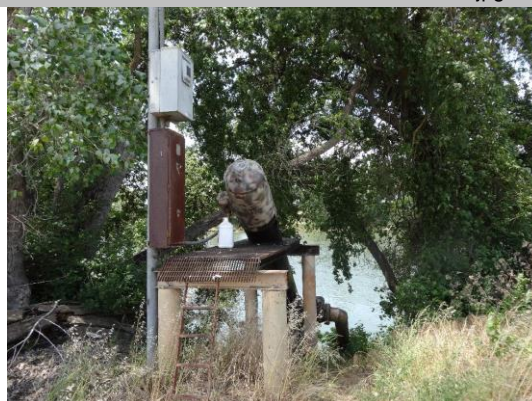
Photo 1 of 3 : UCIP_FA_2019_55175_24033.jpg

WS- slanted pump station with steel structure, and service pole on river bank.

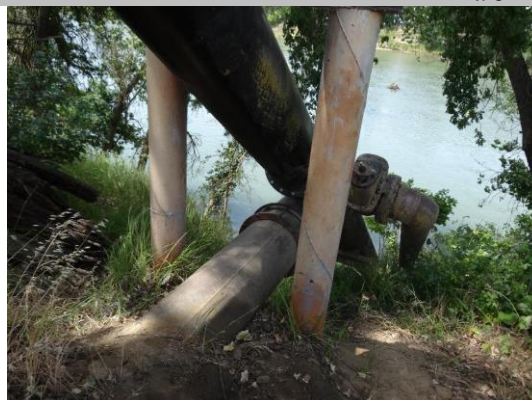
Photo 2 of 3 : UCIP_FA_2019_55175_24032.jpg

WS- inlet steel pipe and main steel pipe in pump station on river bank.

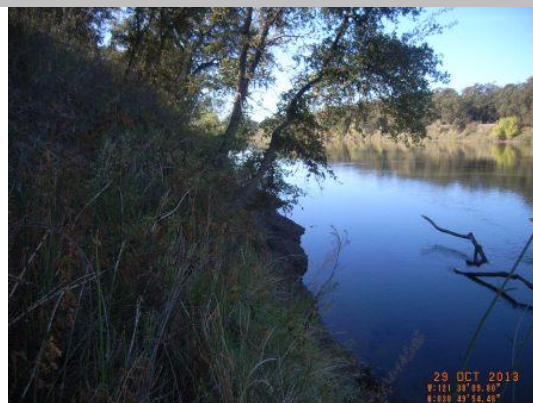
Photo 1 of 1 : FA_2019_RD1001_38_13_20190904_00003.jpg

LM Start	8.57	Rating **	A/W	Issue No.	13
LM End	8.97	Issue Type +	Ma	Location *	WS
Category	Supplemental			GPS Latitude/Longitude	
				Start	End
Item	2017 USACE Erosion Survey			38.836966 °	38.831498 °
				-121.634128 °	-121.636371 °
DWR ID	DWR_RD1001_04_f_2018_13				
Comment Code					
Inspector Comment					
2017 Site ID: FHR 3.8 L					
Status: Eroding					
2017 Field Notes: New erosion along lower slope					
Site History: 2006 - Sandy, silty bank with intermittent pockets of erosion. Rotational failure and tree pop outs are most of the problem. Some upper slope fluvial erosion. 2010 - Site extended upstream. The lower Feather may benefit from a regional repair. 2011 - Site combined with 3.6. Minimal new erosion. 2013 - New erosion observed at bank toe. Trees on site now have exposed roots.

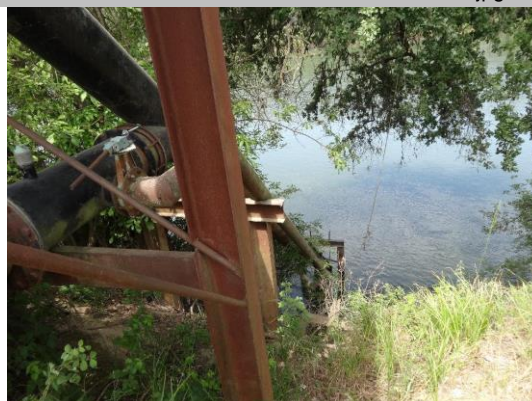
Photo 2 of 3 : UCIP_FA_2019_55177_24001.jpg

WS- inlet pipe and main pipe in pump station on river bank.

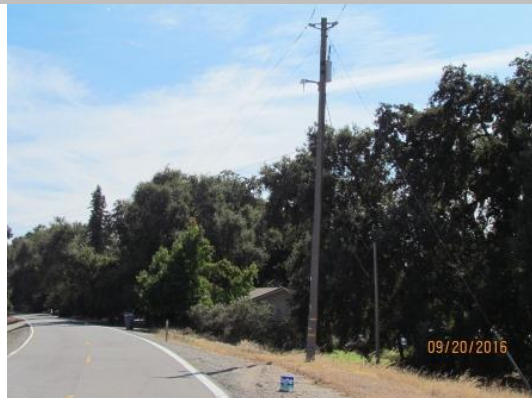
Photo 1 of 1 : FA_2019_RD1001_38_80_20190904_00039.jpg

LM Start	9.52	Rating **	M	Issue No.	80
LM End	9.52	Issue Type +	En	Location *	WS
Category	Earthen Levee			GPS Latitude/Longitude	
				Start	End
Item	Encroachments			38.823911 °	38.823911 °
				-121.639869 °	-121.639869 °
DWR ID	DWR_RD1001_04_s_2016_80				
Comment Code					
PO : Pole					
Inspector Comment

View of pole on waterside crown.

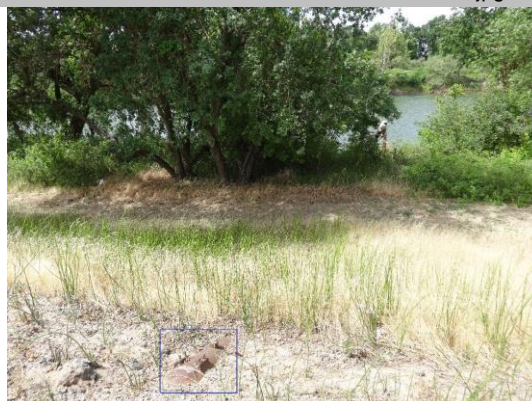
Photo 1 of 3 : UCIP_FA_2019_55179_24134.jpg

WS- exposed pipe on levee slope and pump station in river bank.

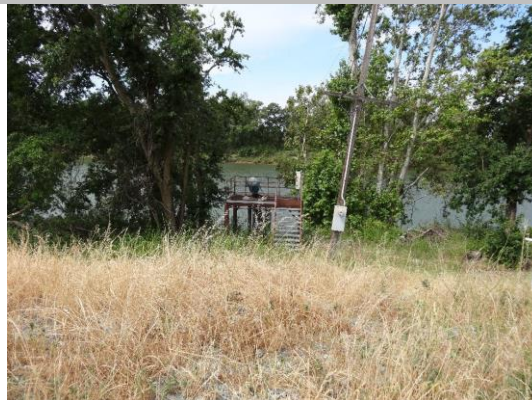
Photo 1 of 3 : UCIP_FA_2019_55180_23977.jpg

WS- slant pump on steel structure in river bank.

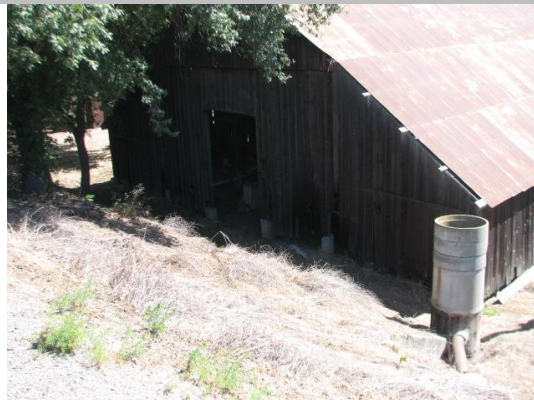
Photo 1 of 1 : FA_2019_RD1001_38_29_20190904_00013.jpg

LM Start	10.60	Rating **	M	Issue No.	29							
LM End	10.60	Issue Type +	En	Location *	LS							
Category	Earthen Levee		GPS Latitude/Longitude									
			Start	End								
Item	Encroachments		38.809256 °	38.809256 °								
			-121.633908 °	-121.633908 °								
DWR ID	DWR_RD1001_04_s_2013_29											
Comment Code												
BU : Building												
Inspector Comment

The building is within the easement of the levee.

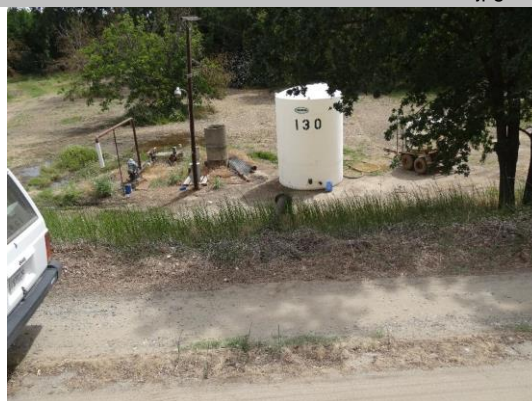
Photo 2 of 3 : UCIP_FA_2019_55181_23973.jpg

LS- overview of landside of the levee.

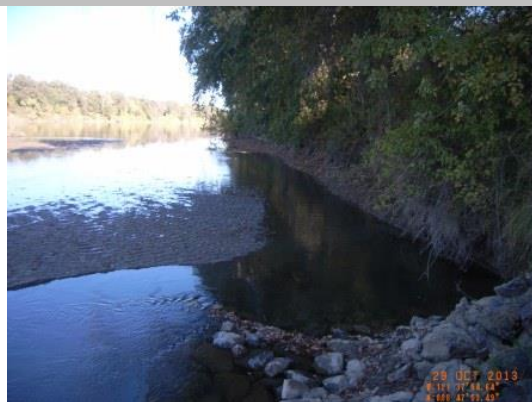
Photo 1 of 1 : FA_2019_RD1001_38_10_20190904_00002.jpg

LM Start	11.18	Rating **	A/W	Issue No.	10
LM End	11.37	Issue Type +	Ma	Location *	WS
Category	Supplemental			GPS Latitude/Longitude	
				Start	End
Item	2017 USACE Erosion Survey			38.800920 °	38.798165 °
				-121.633050 °	-121.631939 °
DWR ID	DWR_RD1001_04_f _ 2018_10				
Comment Code					
Inspector Comment					
2017 Site ID: FHR 1.0 L					
Status: Eroding					
2017 Field Notes: Significant new erosion along lower bank.					
Site History: 2000 - Site is relatively stable except for some toe erosion at the upstream end, recommend monitoring the upstream end. 2004 - Some new block failures (10ft deep) at the toe of the upstream end.					
2007 - Some minor new slumping at the waterline. 2013 - Minor new erosion along the bank toe.

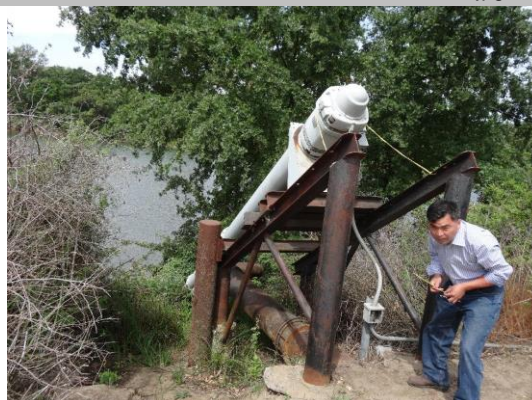
Photo 3 of 3 : UCIP_FA_2019_55966_23968.jpg

WS- slant pump, pipe on steel piles.

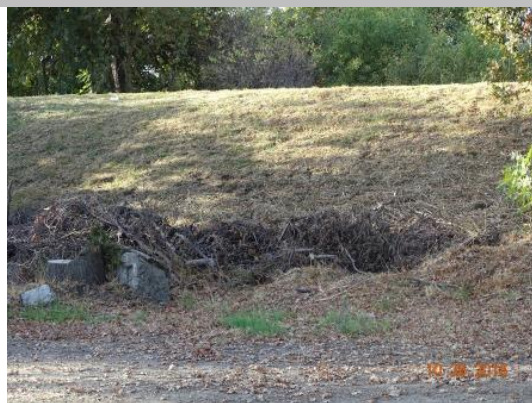
Photo 1 of 1 : FA_2019_RD1001_38_53_20190904_00026.jpg

LM Start	12.44	Rating **	M	Issue No.	53
LM End	12.44	Issue Type +	En	Location *	LS
Category	Earthen Levee			GPS Latitude/Longitude	
				Start	End
Item	Encroachments			38.786444 °	38.786444 °
				-121.619165 °	-121.619165 °
DWR ID	DWR_RD1001_04_s_2018_53				
Comment Code					
PR : Prunings					
Inspector Comment					
Remove prunings from levee toe, Spring 2019.

View looking at landside toe of prunings on levee toe, Fall 2018.

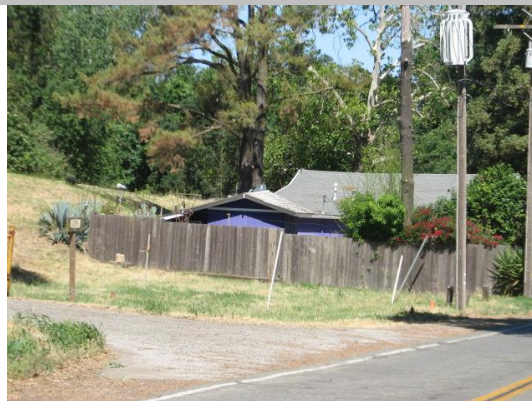
Photo 1 of 1 : FA_2019_RD1001_38_25_20190904_00010.jpg

LM Start	12.48	Rating **	U	Issue No.	25
LM End	12.48	Issue Type +	En	Location *	LS
Category	Earthen Levee			GPS Latitude/Longitude	
				Start	End
Item	Encroachments			38.786073 °	38.786073 °
				-121.618522 °	-121.618522 °
DWR ID	DWR_RD1001_04_s_2012_25				
Comment Code					
BU : Building					
Inspector Comment

An unpermitted building is at the toe of the levee.

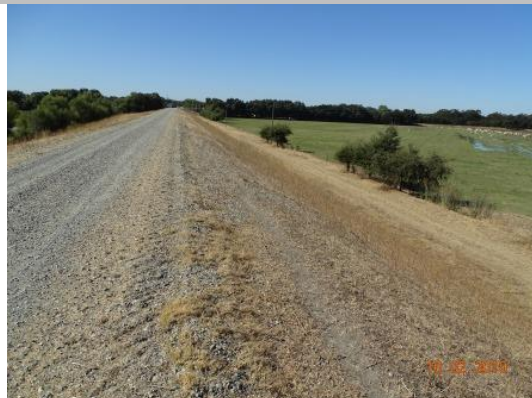
Photo 1 of 1 : FA_2019_RD1001_39_12_20191029_00022.jpg

LM Start	0.00	Rating **	A	Issue No.	12
LM End	5.39	Issue Type +	Ma	Location *	LS
Category	Earthen Levee			GPS Latitude/Longitude	
				Start	End
Item	Vegetation			38.781206 °	38.831070 °
				-121.605445 °	-121.529769 °
DWR ID	DWR_RD1001_05_f_2019_12				
Comment Code					
V1 : Control annual grass and weeds on the levee slopes and easements.					
Inspector Comment					
The annual vegetation is well maintained, Fall 2019.

View looking downstream landside at the well maintained vegetation, Fall 2019.

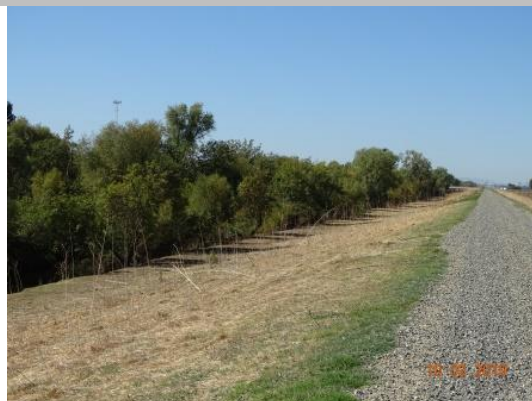
Photo 1 of 1 : FA_2019_RD1001_39_14_20191029_00023.jpg

LM Start	0.00	Rating **	A	Issue No.	14
LM End	5.39	Issue Type +	Ma	Location *	WS
Category	Earthen Levee			GPS Latitude/Longitude	
				Start	End
Item	Vegetation			38.781206 °	38.831070 °
				-121.605445 °	-121.529769 °
DWR ID	DWR_RD1001_05_f_2019_14				
Comment Code					
V1 : Control annual grass and weeds on the levee slopes and easements.					
Inspector Comment					
The annual vegetation is well maintained, Fall 2019.

View looking downstream waterside at the well maintained vegetation, Fall 2019.

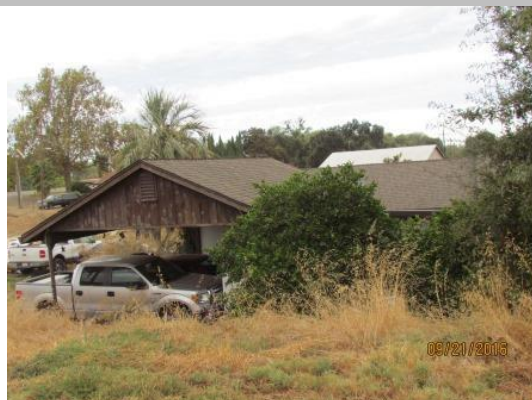
Photo 1 of 1 : FA_2019_RD1001_39_13_20190904_00006.jpg

LM Start	0.05	Rating **	M	Issue No.	13
LM End	0.05	Issue Type +	En	Location *	LS
Category	Earthen Levee			GPS Latitude/Longitude	
				Start	End
Item	Encroachments			38.781881 °	38.781881 °
				-121.605215 °	-121.605215 °
DWR ID	DWR_RD1001_05_f_2016_13				
Comment Code					
BU : Building					
Inspector Comment					
House and carport are at landside levee toe.

View of a house and carport that are at the levee toe.

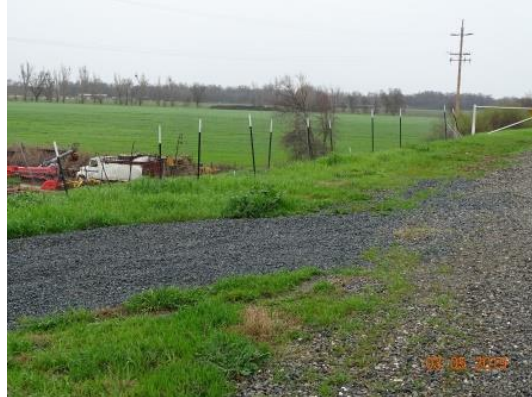
Photo 1 of 1 : FA_2019_RD1001_39_15_20190904_00007.jpg

LM Start	0.09	Rating **	M	Issue No.	15
LM End	0.11	Issue Type +	En	Location *	LS
Category	Earthen Levee			GPS Latitude/Longitude	
				Start	End
Item	Encroachments			38.782447°	38.782717°
				-121.605008°	-121.604870°
DWR ID	DWR_RD1001_05_s_2019_15				
Comment Code					
FE : Fence					
Inspector Comment					
Temporary fence needs to be removed, Fall 2019.

View looking upstream landside at a temporary goat fence, Spring 2019.

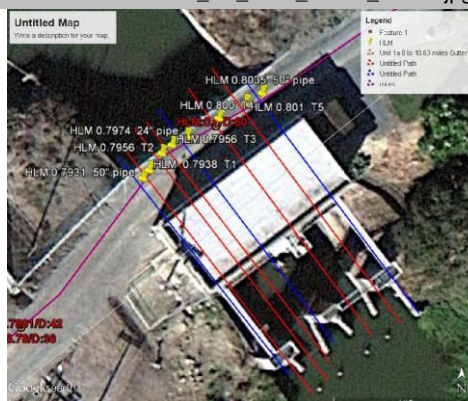
Photo 1 of 3 : UCIP_FA_2019_14393_23697.jpg

Comment Code						
Inspector Comment						
DS_ID:22610						
FS_ID:14393						
EP_NO: N/A						
Repair Type: Non-Urgent						
Crossing Status: Found						
UCIP Comments: 08/22/2019 Record has been updated with USACE O&M reference. (O. Magana - DWR UCIP)						
05/15/2013 - needs repair of concrete piers on waterside. Rebar exposed from the pier. Even though this pier is functionally not linked to the pipe, it needs repair. (P. Amatya - DWR UCIP)						
FIELD_STRUCT_DESC: [RD 1001 Drainage Pumping Plant] 5 of 8: 24-inch reinforced concrete drainage discharge pipe through the levee, 25 feet below the crown. Five 60-inch by 84-inch reinforced concrete drainage tunnels through the levee, 25 feet below the crown. One tunnel has a 60-inch pump installed inside and is gated on the waterside (WS) end. Two 50-inch steel drainage discharge pipes through the levee, 25 feet below the crown. All tunnels and pipes are gated. Concrete headwall and railing along the landside (LS). (Reclamation District No. 1001). [Additional Reference(s): DWR Levee Log, 1993. USACE Sacramento O&M Manual, Unit 142 Back Levee of Reclamation District No. 1001, June 1959, Revised 04 May 2018, five 4-foot by 5-foot culverts, two 50-inch pipe, and one 20-inch pipe (HLM 0.80)].

Location of pipes and tunnels. 24-inch steel pipe located at 5th from the left.

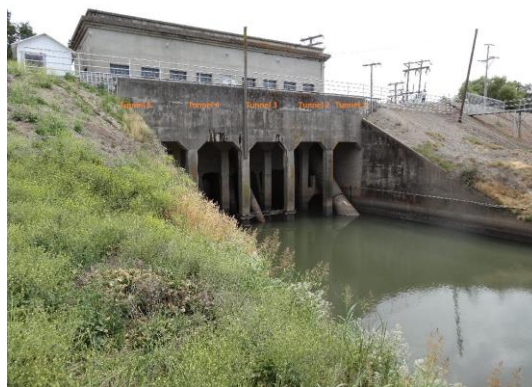
Photo 2 of 3 : UCIP_FA_2019_14393_23696.jpg

LS- Drainage structure with tunnels, pipes and pump house. Tunnel 1 at far right and tunnel 5 at far left. The pipe is located inside tunnel 3.

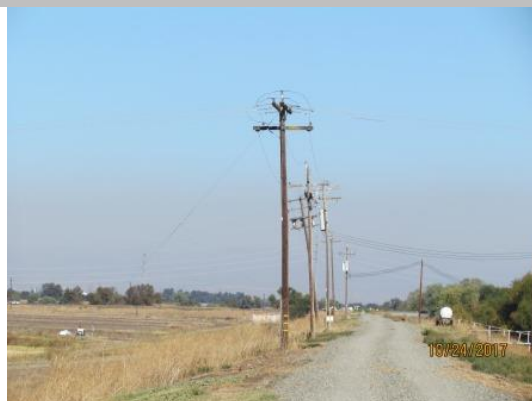
Photo 1 of 1 : FA_2019_RD1001_39_7_20190904_00001.jpg

LM Start	3.56	Rating **	M	Issue No.	7
LM End	3.81	Issue Type +	En	Location *	LS
Category	Earthen Levee			GPS Latitude/Longitude	
				Start	End
Item	Encroachments			38.814919 °	38.817178 °
				-121.556712 °	-121.552965 °
DWR ID	DWR_RD1001_05_s_2012_7				
Comment Code					
PO : Pole					
Inspector Comment

View of poles on the landside shoulder looking downstream.

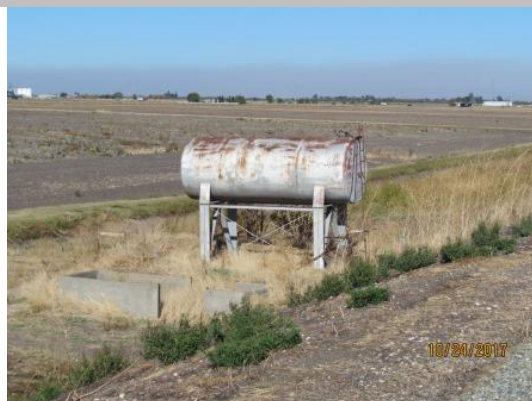
Photo 1 of 1 : FA_2019_RD1001_39_10_20190904_00005.jpg

LM Start	3.81	Rating **	M	Issue No.	10
LM End	3.81	Issue Type +	En	Location *	LS
Category	Earthen Levee			GPS Latitude/Longitude	
				Start	End
Item	Encroachments			38.817178 °	38.817178 °
				-121.552965 °	-121.552965 °
DWR ID	DWR_RD1001_05_s_2012_10				
Comment Code					
TA : Tank					
Inspector Comment					
Fuel tank at landside levee toe.

View of tank on the landside shoulder looking downstream.

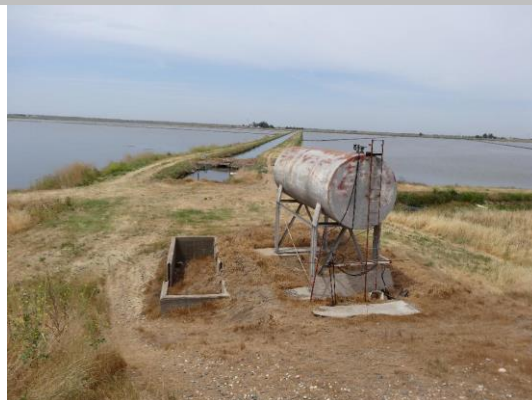
Photo 3 of 3 : UCIP_FA_2019_14484_23897.jpg

Comment Code						
Inspector Comment						
DS_ID:22595 FS_ID:14484 EP_NO: 1896 Repair Type: Non-Urgent Crossing Status: Found UCIP Comments: 05/15/2013 - slide gate in concrete box on waterside levee toe.- cracked headwall on landside- working during field survey (P. Amatya - DWR UCIP) FIELD_STRUCT_DESC: *ABANDONED* 2 of 3: 20-inch asbestos bonded corrugated metal irrigation discharge pipe through the levee, 2.13 feet below the crown. Three vertical pumps on a wooden piling structure in the stream. Walkway to the pumps. Slide gate in a concrete box on the waterside (WS). (Permit No. 1896, [permit missing]). [Additional Reference(s): DWR Levee Log, 1993]. FS Date: 5/15/2013

LS- overview of irrigation ditch on levee toe (top)

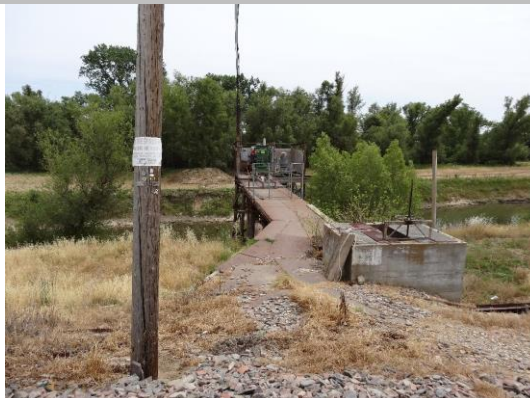
Photo 1 of 3 : UCIP_FA_2019_14472_23891.jpg

Comment Code						
Inspector Comment						
DS_ID:22613 FS_ID:14472 EP_NO: 1896 Repair Type: Non-Urgent Crossing Status: Found UCIP Comments: 05/15/2013 - slide gate in concrete box on waterside levee toe.- cracked headwall on landside- working during field survey (P. Amatya - DWR UCIP) FIELD_STRUCT_DESC: *ABANDONED* 3 of 3: 30-inch asbestos bonded corrugated metal irrigation discharge pipe through the levee, 2.13 feet below the crown. Three vertical pumps on a wooden piling structure in the stream. Walkway to the pumps. Slide gate in a concrete box on the waterside (WS). (Permit No. 1896, [permit missing]). [Additional Reference(s): DWR Levee Log, 1993]. FS Date: 5/15/2013

WS- pump station, walkway, and slide gate in concrete box on levee toe

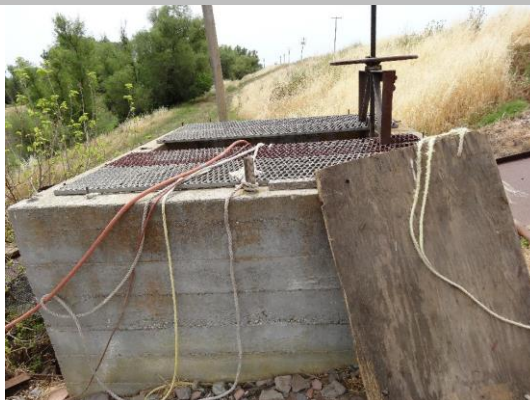
Photo 2 of 3 : UCIP_FA_2019_14472_23890.jpg

WS- slide gate in concrete box on levee toe

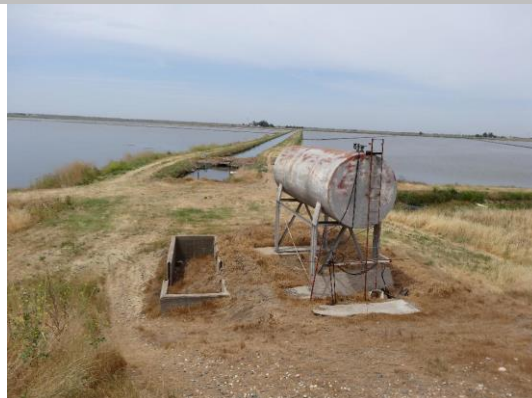
Photo 3 of 3 : UCIP_FA_2019_14472_23889.jpg

Comment Code						
Inspector Comment						
DS_ID:22613 FS_ID:14472 EP_NO: 1896 Repair Type: Non-Urgent Crossing Status: Found UCIP Comments: 05/15/2013 - slide gate in concrete box on waterside levee toe.- cracked headwall on landside- working during field survey (P. Amatya - DWR UCIP) FIELD_STRUCT_DESC: *ABANDONED* 3 of 3: 30-inch asbestos bonded corrugated metal irrigation discharge pipe through the levee, 2.13 feet below the crown. Three vertical pumps on a wooden piling structure in the stream. Walkway to the pumps. Slide gate in a concrete box on the waterside (WS). (Permit No. 1896, [permit missing]). [Additional Reference(s): DWR Levee Log, 1993]. FS Date: 5/15/2013

LS- pipes discharge water in irrigation ditch on landside (top)

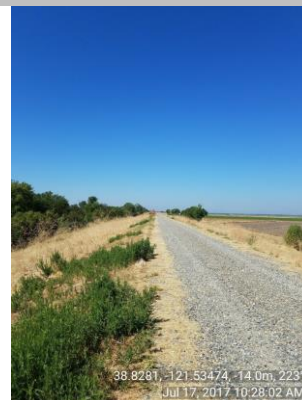
Photo 1 of 3 : LEVAL_FA_2019_493_1759.jpg

LM Start	5.05	Rating **	A/W	Issue No.	8
LM End	5.06	Issue Type +	Ma	Location *	WS
Category	Supplemental			GPS Latitude/Longitude	
				Start	End
Item	2017 Storm Damage			38.828100 °	38.828188 °
				-121.534740 °	-121.534625 °
DWR ID	RD 1001-03				
Comment Code					
Inspector Comment					
Levee Evaluation Comments					
Description:					
Site ID No:493					
Site Designation:RD 1001-03					
Repair Type: Erosion					
Rating:Serious					
Field Date:7/17/2017					
Notes: Serious per senior review

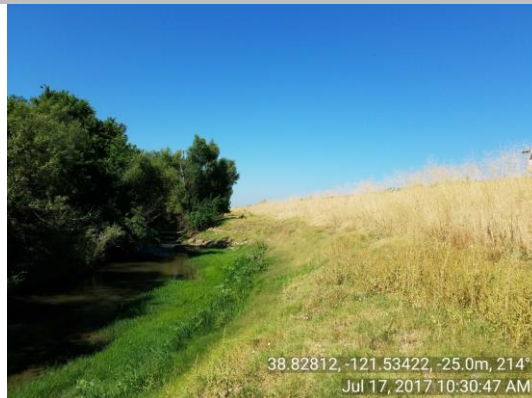
Photo 2 of 3 : LEVAL_FA_2019_493_1762.jpg

LM Start	5.05	Rating **	A/W	Issue No.	8 (cont)	
LM End	5.06	Issue Type +	Ma	Location *	WS	
Category	Supplemental			GPS Latitude/Longitude		
				Start		End
Item	2017 Storm Damage			38.828100 °		38.828188 °
				-121.534740 °		-121.534625 °
DWR ID	RD 1001-03					
Comment Code						
Inspector Comment						
Levee Evaluation Comments						
Description:						
Site ID No:493						
Site Designation:RD 1001-03						
Repair Type: Erosion						
Rating:Serious						
Field Date:7/17/2017						
Notes: Serious per senior review

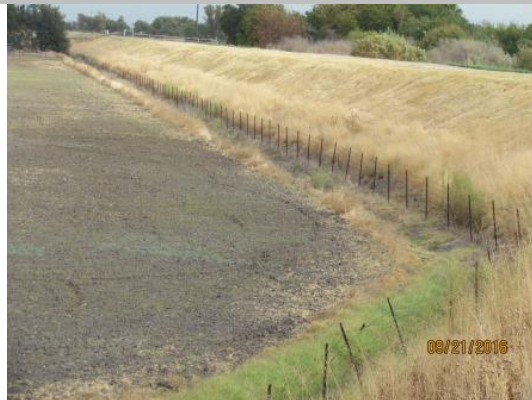
Photo 1 of 1 : FA_2019_RD1001_40_20_20190904_00006.jpg

LM Start	0.01	Rating **	M	Issue No.	20
LM End	0.47	Issue Type +	En	Location *	LS
Category	Earthen Levee			GPS Latitude/Longitude	
				Start	End
Item	Encroachments			38.831276 °	38.837276 °
				-121.529645 °	-121.526592 °
DWR ID	DWR_RD1001_06_f_2016_20				
Comment Code					
FE : Fence					
Inspector Comment					
There is a fence along the landside levee toe.

View of fence along the landside levee toe looking upstream.

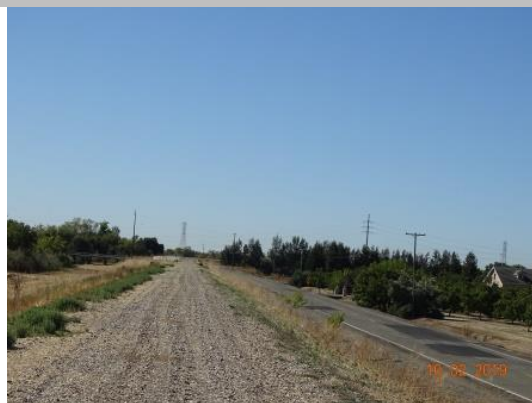
Photo 1 of 1 : FA_2019_RD1001_40_25_20191029_00055.jpg

LM Start	0.02	Rating **	A	Issue No.	25
LM End	4.72	Issue Type +	Ma	Location *	LS
Category	Earthen Levee			GPS Latitude/Longitude	
				Start	End
Item	Vegetation			38.831229 °	38.896324 °
				-121.529506 °	-121.520546 °
DWR ID	DWR_RD1001_06_f_2019_25				
Comment Code					
V1 : Control annual grass and weeds on the levee slopes and easements.					
Inspector Comment					
The annual vegetation is well maintained, Fall 2019.

View looking downstream landside at the well maintained vegetation, Fall 2019.

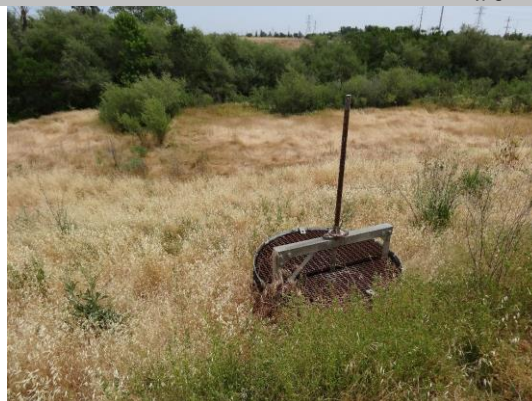
Photo 1 of 3 : UCIP_FA_2019_55186_23508.jpg

Comment Code					
Inspector Comment					
DS_ID:22636 FS_ID:55186 EP_NO: N/A Repair Type: Non-Urgent Crossing Status: Found UCIP Comments: 08/21/2019 Record has been updated from No Action Needed to Non-Urgent due to limited inspection on the LS and missing permit authorizing crossing. Record updated with USACE O&M reference. Dense vegetation prevented a thorough inspection of the levee slopes. Pipe is selected for DMP internal video inspection. A good evaluation of pipe condition will be available once the DMP internal video inspection is completed. (O. Magana - DWR UCIP)05/15/2013 - steep levee slope- dense vegetation (P. Amatya - DWR UCIP) FIELD_STRUCT_DESC: 36-inch corrugated metal gravity drainage pipe through the levee, 17.6 feet below the crown. Slide gate in a 48-inch corrugated metal pipe (CMP) riser on the waterside (WS) slope. Concrete U-shaped headwall at the landside (LS) toe. Pipe crosses under the channel. [Additional Reference(s): DWR Levee Log, 1993. USACE Sacramento O&M Manual, Unit 142 - Back Levee of Reclamation District No. 1001, June 1959, Revised 04 May 2018, 36-inch pipe (HLM 0.03)]. FS Date: 8/21/2019 12:52:00 PM

WS- slide gate, air vent in CMP riser.

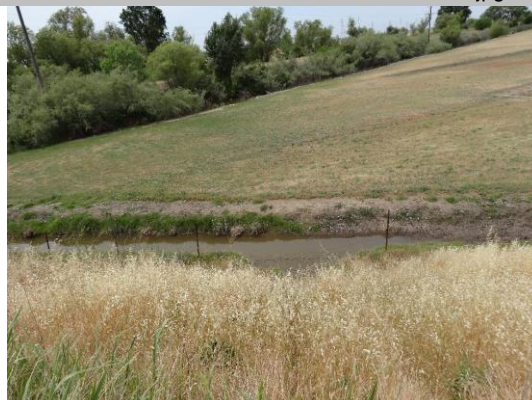
Photo 2 of 3 : UCIP_FA_2019_55186_23507.jpg

LS- pipe discharges into irrigation ditch

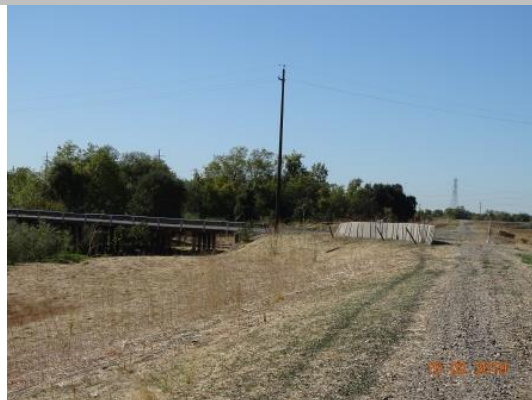
Photo 1 of 2 : FA_2019_RD1001_40_16_20191029_00058.jpg

LM Start	0.47	Rating **	U	Issue No.	16
LM End	0.47	Issue Type +	En	Location *	CR
Category	Earthen Levee			GPS Latitude/Longitude	
				Start	End
Item	Encroachments			38.837366 °	38.837366 °
				-121.526579 °	-121.526579 °
DWR ID	DWR_RD1001_06_f_2018_16				
Comment Code					
FE : Fence					
Inspector Comment					
The solid fence needs to be removed from the crown, Fall 2019.

View looking downstream waterside crown at an unpermitted solid fence, Fall 2019.

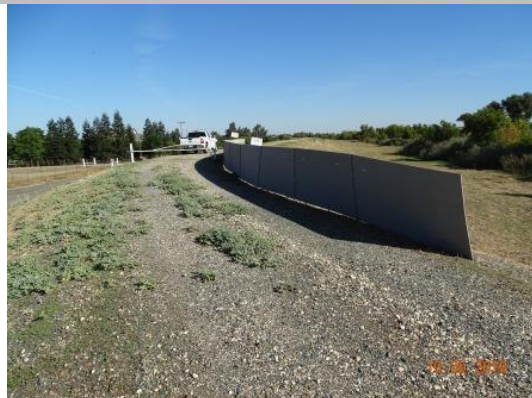
Photo 2 of 2 : FA_2019_RD1001_40_16_20190904_00004.jpg

LM Start	0.47	Rating **	U	Issue No.	16 (cont)	
LM End	0.47	Issue Type +	En	Location *	CR	
Category	Earthen Levee			GPS Latitude/Longitude		
				Start	End	
Item	Encroachments			38.837366 °	38.837366 °	
				-121.526579 °	-121.526579 °	
DWR ID	DWR_RD1001_06_f_2018_16					
Comment Code						
FE : Fence						
Inspector Comment						
The solid fence needs to be removed from the crown, Fall 2019.

View looking upstream waterside crown at an unpermitted solid fence, Fall 2018.

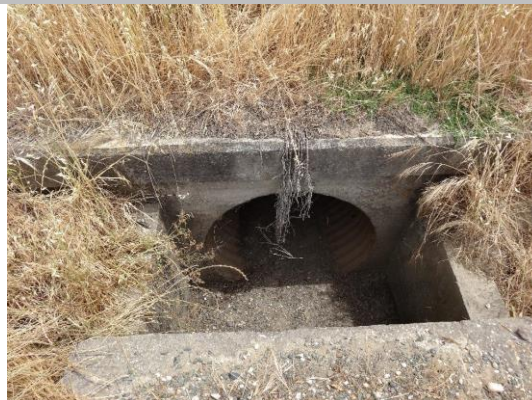
Photo 2 of 3 : UCIP_FA_2019_55187_23509.jpg

Comment Code						
Inspector Comment						
DS_ID:22635 FS_ID:55187 EP_NO: N/A Repair Type: Non-Urgent Crossing Status: Found UCIP Comments: 08/21/2019 Record has been updated from No Action Needed to Non-Urgent, no permit has been issued authorizing crossing. Record updated with USACE O&M reference. A good evaluation of pipe condition will be available once the DMP internal video inspection is completed. (O. Magana - DWR UCIP) FIELD_STRUCT_DESC: 36-inch corrugated metal gravity drainage pipe through the levee, 14.3 feet below the crown. Slide gate in a 48-inch corrugated metal pipe (CMP) riser on the waterside (WS) slope. Concrete headwall at the landside (LS) toe. Pipe crosses under the channel. [Additional Reference(s): DWR Levee Log, 1993. USACE Sacramento O&M Manual, Unit 142 - Back Levee of Reclamation District No. 1001, June 1959, Revised 04 May 2018, 36-inch pipe (HLM 0.56)]. FS Date: 8/21/2019 12:52:00 PM

LS- concrete distribution box with headwall on levee toe.

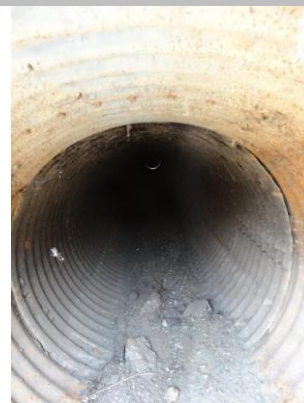
Photo 3 of 3 : UCIP_FA_2019_55187_23511.jpg

LS- inside view of CMP. Thin layer of soil deposited in the pipe

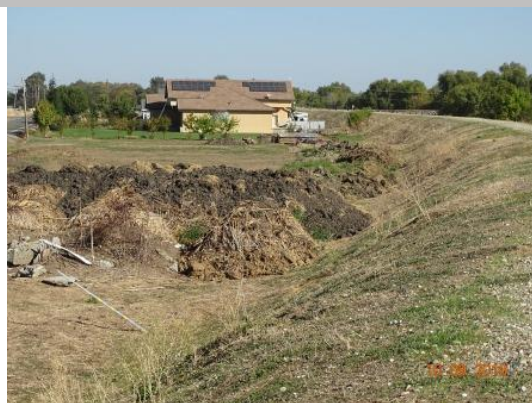
Photo 1 of 1 : FA_2019_RD1001_40_21_20190904_00007.jpg

LM Start	0.77	Rating **	U	Issue No.	21
LM End	0.85	Issue Type +	En	Location *	LS
Category	Earthen Levee			GPS Latitude/Longitude	
				Start	End
Item	Encroachments			38.841522 °	38.842611 °
				-121.524833 °	-121.524533 °
DWR ID	DWR_RD1001_06_f_2018_21				
Comment Code					
MA : Material					
Inspector Comment					
Soil material piled on the levee toe needs to be removed, Fall 2019.

View looking upstream landside where soil has been dumped on the levee toe, Fall 2018.

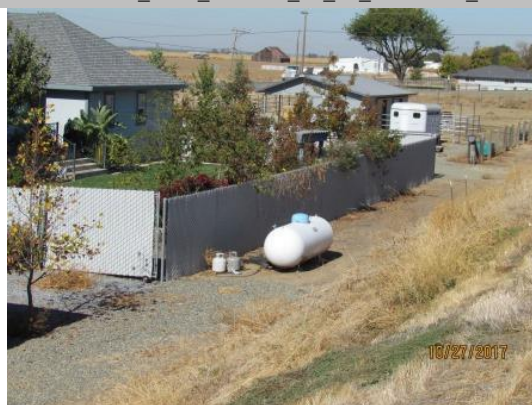
Photo 1 of 1 : FA_2019_RD1001_40_46_20190904_00010.jpg

LM Start	0.95	Rating **	M	Issue No.	46
LM End	0.95	Issue Type +	En	Location *	LS
Category	Earthen Levee			GPS Latitude/Longitude	
				Start	End
Item	Encroachments			38.844109 °	38.844109 °
				-121.524375 °	-121.524375 °
DWR ID	DWR_RD1001_06_s_2012_46				
Comment Code					
TA : Tank					
Inspector Comment					
Propane tank is within the landside easement of the levee.

View of a propane tank that is within the landside easement of the levee.

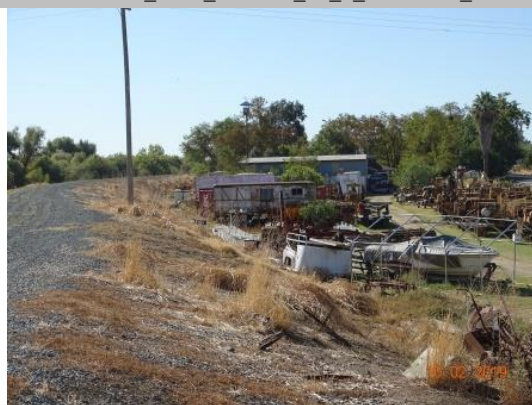
Photo 1 of 1 : FA_2019_RD1001_40_3_20191029_00057.jpg

LM Start	1.45	Rating **	M	Issue No.	3
LM End	1.53	Issue Type +	En	Location *	LS
Category	Earthen Levee			GPS Latitude/Longitude	
				Start	End
Item	Encroachments			38.851234 °	38.852445 °
				-121.524421 °	-121.524809 °
DWR ID	DWR_RD1001_06_s_2012_3				
Comment Code					
EQ : Equipment					
Inspector Comment					
Remove equipment from levee toe.

View looking downstream of the equipment at the landside levee toe, Fall 2019.

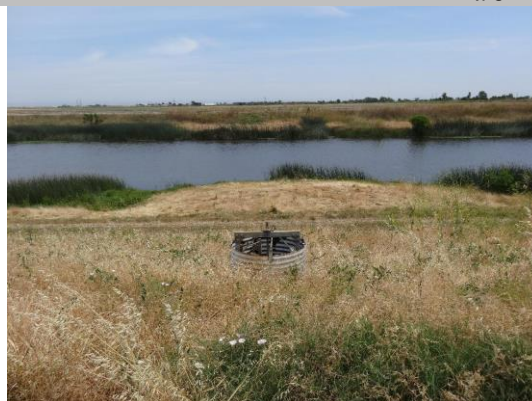
Photo 1 of 3 : UCIP_FA_2019_55199_23467.jpg

DS_ID:22617
FS_ID:55199
EP_NO: N/A
Repair Type: Urgent
Crossing Status: Found
UCIP Comments: 08/21/2019 Pipe has been upgraded to Urgent: Pipe Integrity due to deteriorated pipe section at inlet. DMP internal video inspection still hasn't been completed to determine extent of damage through levee. Record updated with USACE O&M reference. (O. Magana - DWR UCIP)05/15/2013 - visible damage to pipe on opening at inlet due to high corrosion.- video inspection recommended. (P. Amatya - DWR UCIP)
FIELD_STRUCT_DESC: 36-inch corrugated metal gravity drainage pipe through the levee, 12.5 feet below the crown. Slide gate in a 48-inch corrugated metal pipe (CMP) riser on the waterside (WS) slope. Concrete headwall at the landside (LS) toe. Pipe crosses under the channel. [Additional Reference(s): DWR Levee Log, 1993. USACE Sacramento O&M Manual, Unit 142 - Back Levee of Reclamation District No. 1001, June 1959, Revised 04 May 2018, 30-inch pipe (HLM 1.72)].

WS- slide gate in CMP riser on levee slope.

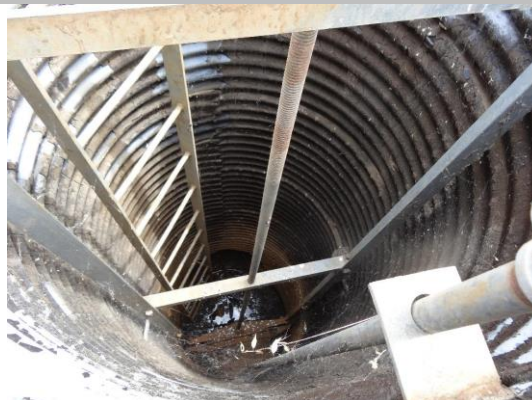
Photo 2 of 3 : UCIP_FA_2019_55199_23466.jpg

WS- slide gate, air vent pipe in CMP riser on levee slope.

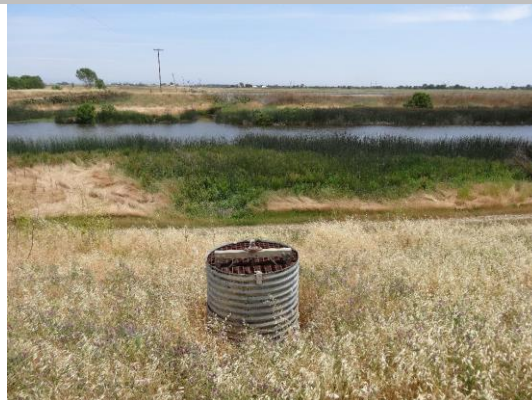
Photo 1 of 3 : UCIP_FA_2019_55196_23445.jpg

Comment Code						
Inspector Comment						
DS_ID:22616 FS_ID:55196 EP_NO: N/A Repair Type: Non-Urgent Crossing Status: Found UCIP Comments: 08/21/2019 Record remains Non-Urgent due to missing permit authorizing crossing and limited inspection on the LS. Dense vegetation prevented a thorough inspection of levee section at pipe location. Record updated with USACE O&M reference. (O. Magana - DWR UCIP)05/15/2013 - pipe buried/submerged on LS-needs cleaning of LS pipe end opening. (P. Amatya - DWR UCIP) FIELD_STRUCT_DESC: 24-inch corrugated metal gravity drainage pipe through the levee, 15.5 feet below the crown. Slide gate in a 36-inch corrugated metal pipe (CMP) riser on the waterside (WS) slope. Concrete headwall at the landside (LS) toe. Pipe crosses under the channel. [Additional Reference(s): DWR Levee Log, 1993. USACE Sacramento O&M Manual, Unit 142 - Back Levee of Reclamation District No. 1001, June 1959, Revised 04 May 2018, 24-inch pipe (HLM 2.03)]. FS Date: 8/21/2019 12:54:00 PM

WS- slide gate in CMP riser on levee slope.

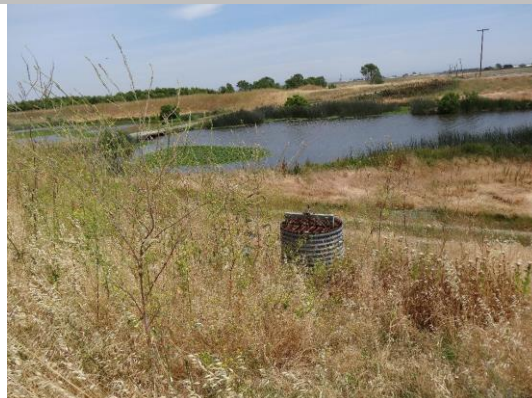
Photo 1 of 3 : UCIP_FA_2019_55197_23434.jpg

DS_ID:22615
FS_ID:55197
EP_NO: N/A
Repair Type: Non-Urgent
Crossing Status: Found
UCIP Comments: 08/21/2019 Record has been updated from No Action Needed to Non-Urgent, dense vegetation along the LS slope prevented a thorough inspection. Record updated with USACE O&M reference. (O. Magana - DWR UCIP)05/15/2013 - a concrete vault found off the pipe alignment on LS.- a CMP found across the road on LS.- a slide gate in CMP riser on levee slope on WS. (P. Amatya - DWR UCIP)
FIELD_STRUCT_DESC: 24-inch corrugated metal gravity drainage pipe through the levee, 15.5 feet below the crown. Slide gate in a 36-inch corrugated metal pipe (CMP) riser on the waterside (WS) slope. Concrete headwall at the landside (LS) toe. Pipe crosses under the channel. [Additional Reference(s): DWR Levee Log, 1993. USACE Sacramento O&M Manual, Unit 142 - Back Levee of Reclamation District No. 1001, June 1959, Revised 04 May 2018, 24-inch pipe (HLM 2.05)].

WS- slide gate in CMP riser on levee slope

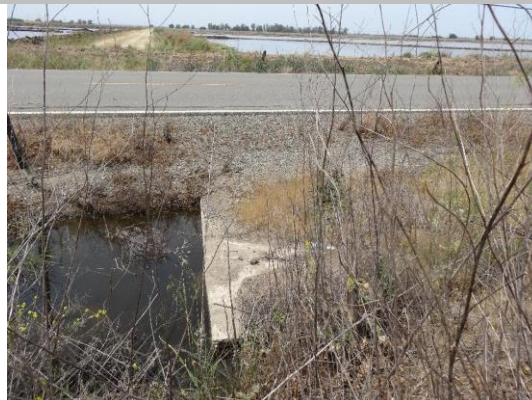
Photo 2 of 3 : UCIP_FA_2019_55197_23433.jpg

LS- a concrete vault found on levee toe.

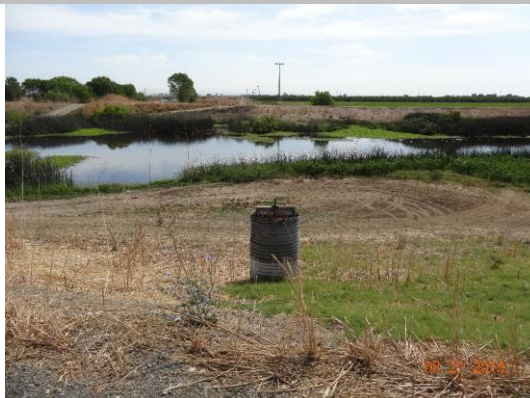
Photo 3 of 3 : UCIP_FA_2019_55197_81232.jpg

WS view: overview of WS. CMP riser with cover located on WS slope.

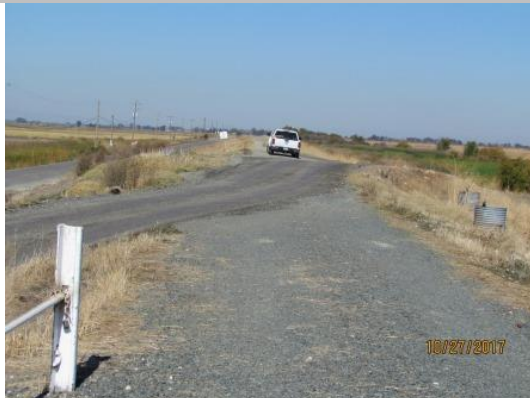
Photo 1 of 1 : FA_2019_RD1001_40_8_20190904_00003.jpg

LM Start	2.05	Rating **	A/W	Issue No.	8	
LM End	2.05	Issue Type +	Ma	Location *	CR	
Category	Earthen Levee			GPS Latitude/Longitude		
				Start		End
Item	Crown Surface / Depressions / Rutting			38.860002 °		38.860002 °
				-121.524873 °		-121.524873 °
DWR ID	DWR_RD1001_06_s_2012_8					
Comment Code						
C2 : Repair depressions or ruts in the crown or slope.						
Inspector Comment						
There are depressions on the crown where there is cross traffic. Monitor this area and fix as needed.

View of crown where there is cross traffic looking upstream. Monitor this area and fix as needed.

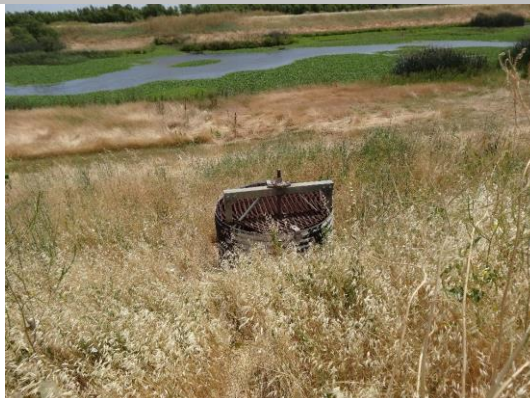
Photo 1 of 3 : UCIP_FA_2019_55198_23431.jpg

Comment Code						
Inspector Comment						
DS_ID:22626 FS_ID:55198 EP_NO: N/A Repair Type: Non-Urgent Crossing Status: Found UCIP Comments: 08/21/2019 Record has been updated from No Action Needed to Non-Urgent, due to a missing permit authorizing pipe and limited inspection due to dense vegetation on the LS. Dense vegetation prevented a thorough inspection on the LS slope and toe. Record updated with USACE O&M reference. (O. Magana - DWR UCIP)05/15/2013 - pipe submerged into water on landside. (P. Amatya - DWR UCIP) FIELD_STRUCT_DESC: 36-inch corrugated metal gravity drainage pipe through the levee, 16 feet below the crown. Slide gate in a 48-inch corrugated metal pipe (CMP) riser on the waterside (WS) slope. Concrete headwall at the landside (LS) toe. Pipe crosses under the channel. [Additional Reference(s): DWR Levee Log, 1993. USACE Sacramento O&M Manual, Unit 142 - Back Levee of Reclamation District No. 1001, June 1959, Revised 04 May 2018, 36-inch pipe (HLM 2.31)]. FS Date: 8/21/2019 12:55:00 PM

WS- slide gate on CMP on levee slope

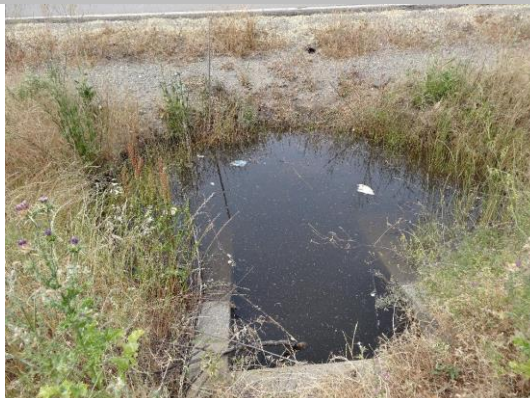
Photo 2 of 3 : UCIP_FA_2019_55198_23430.jpg

LS- headwall and submerged pipe. Pipe not visible due to water.

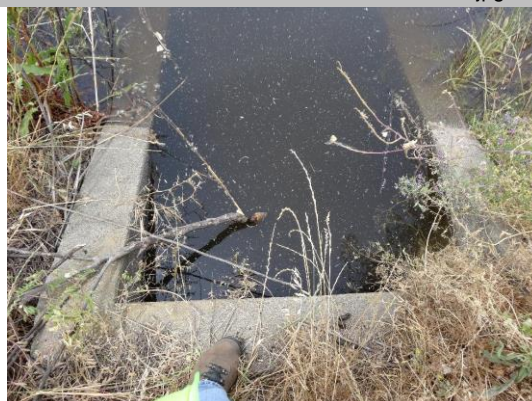
Photo 3 of 3 : UCIP_FA_2019_55198_23432.jpg

LS- headwall and submerged pipe

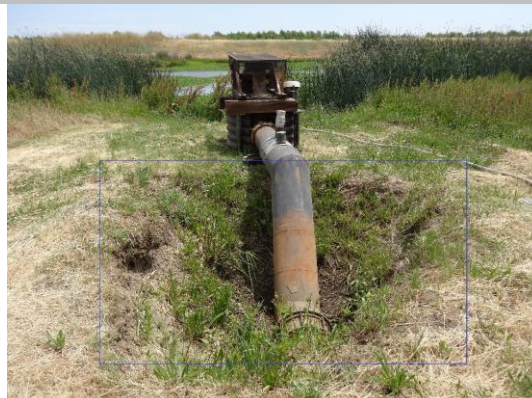
Photo 2 of 3 : UCIP_FA_2019_55201_23429.jpg

Comment Code						
Inspector Comment						
DS_ID:22622 FS_ID:55201 EP_NO: 12208 Repair Type: Non-Urgent Crossing Status: Found UCIP Comments: 08/21/2019 Crossing has been downgraded from Urgent to Non-Urgent, potential leak is more than 10 feet from WS toe. Still need to contact owner to determine the extent of WS repair. (O. Magana - DWR UCIP)10/18/2018 Same as previous inspection. No documentation is available to determine if there is a pipe integrity issue. Recommend internal inspection of the pipe through the levee to determine the condition of the pipe. Need to contact owner to obtain details of WS repair. Levee is about 8-10 feet high. Crossing remains Urgent due to the unknown reason for WS hole observed in the 2013 inspection (pipe repair or pipe leakage). (O. Magana - DWR UCIP)07/13/2016 Depression on WS berm has been backfilled, but the cause of the erosion was not addressed to my knowledge. As such, pipe integrity problem may still exist. Vegetation growth surrounds pipe on WS berm, in strike contrast to dry grass away from pipe alignment. This could be due to channel draining toward the pipe, or an indication of pipe leakage. (K. Fazel - UCIP)05/15/2013:- large pit at pipe daylight on WS berm, may be due to pipe leakage.- siphon breaker on LS shoulder not found. (P. Amatya - DWR) FIELD_STRUCT_DESC: 16-inch steel irrigation discharge pipe through the levee, 3 feet below the crown. 16-inch low-lift pump in the channel with a 1-inch electrical line also penetrating the levee to the power pole off the landside (LS) toe. 36-inch corrugated metal pipe (CMP) riser on the bank. Vent on the LS shoulder. Siphon breaker/vent on the apex of the pipe near the waterside (WS) pump. Standpipe off the LS toe. Pipe used seasonally only in the absence of groundwater, as per District President Joe Henderson. (16-inch irrigation pipe and 16-inch low-lift pump authorized under Permit No. 12208, 1977 - Thomas A. Cuguet). [Additional Reference(s): DWR Levee Log, 1993]. FS Date: 8/21/2019 12:51:00 PM

WS- large depression on levee berm

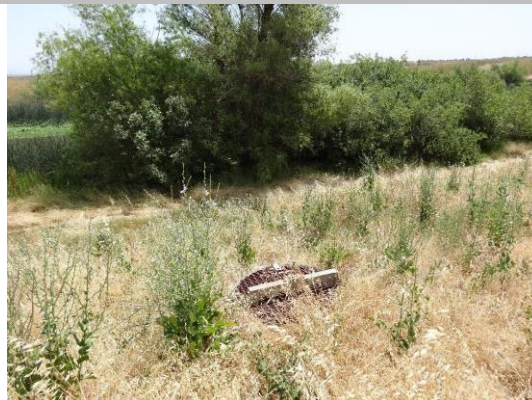
Photo 1 of 3 : UCIP_FA_2019_55203_23401.jpg

Comment Code						
Inspector Comment						
DS_ID:22628 FS_ID:55203 EP_NO: N/A Repair Type: Non-Urgent Crossing Status: Found UCIP Comments: 08/21/2019 Record has been updated from No Action Needed to Non-Urgent, no permit has been identified for crossing and dense vegetation limited inspection. Dense vegetation prevented a thorough inspection of pipe. DWR DMP internal inspection has not been completed. Record will be updated once the internal inspection is available to determine condition of pipe through the levee. Record updated with USACE O&M reference. (O. Magana - DWR UCIP)05/15/2013 - Headwall at the landside toe not found.- concrete box on landside toe. (P. Amatya - DWR UCIP) FIELD_STRUCT_DESC: 24-inch corrugated metal gravity drainage pipe through the levee, 12 feet below the crown. Slide gate in a 36-inch corrugated metal pipe (CMP) riser on the waterside (WS) slope. Concrete headwall at the landside (LS) toe. Pipe crosses under the channel. [Additional Reference(s): DWR Levee Log, 1993. USACE Sacramento O&M Manual, Unit 142 - Back Levee of Reclamation District No. 1001, June 1959, Revised 04 May 2018, 24-inch pipe (HLM 2.70)]. FS Date: 8/21/2019 12:55:00 PM

WS- slide gate on CMP riser on levee slope.

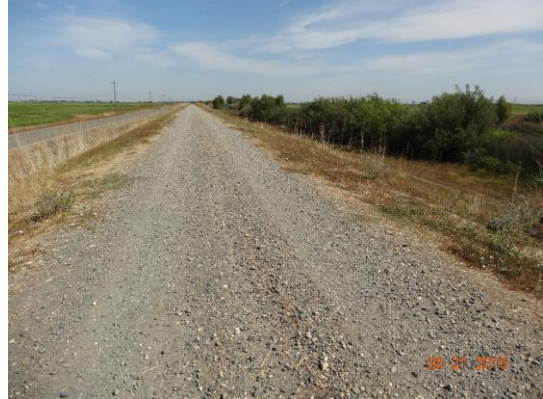
Photo 3 of 3 : UCIP_FA_2019_55203_81242.jpg

Overview of levee crown looking u/s towards pipe crossing.

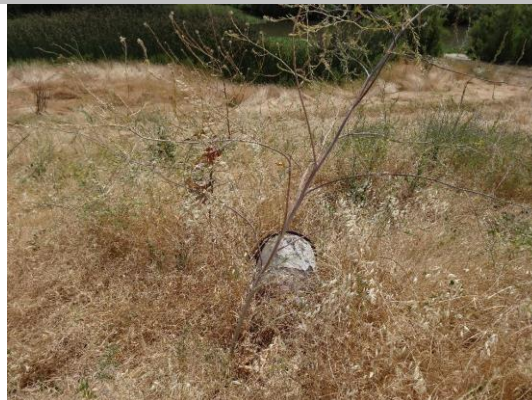
Photo 1 of 3 : UCIP_FA_2019_55204_23382.jpg

Comment Code					
Inspector Comment					
DS_ID:22629 FS_ID:55204 EP_NO: 2768 Repair Type: Non-Urgent Crossing Status: Found UCIP Comments: 08/21/2019 Record remains Non-Urgent, unable to determine the status of the pipe through the levee. Notified DWR Levee Inspector of pipe removal and he will contact LMA to determine status. Need supporting documentation to determine if pipe was removed or abandoned per Title 23/CVFPB approval. Record updated with USACE O&M reference. (O. Magana - DWR UCIP)01/24/2019 Attachment 1 under the 20141008 CVFPB acknowledgement letter indicates excavation and removal of pipe, backfill material, compact, and reseed. Need to confirm work and update UCIP record. (O. Magana - DWR UCIP) 05/15/2013 Pipe appears abandoned and if so should be done so properly.- Pipe capped on waterside.- a concrete pipe support saddle found on waterside levee slope.- also, an abandoned pipe found on landside levee slope. (P. Amatya - DWR UCIP) FIELD_STRUCT_DESC: 14-inch steel irrigation discharge pipe through the levee, 1.3 feet below the crown. Pump on the waterside (WS) toe removed. Gate valve on the WS slope removed. Pipe exposed on both slopes. Pipe discharges into a culvert on the landside (LS) toe which traverses under Pacific Avenue. (Removal and replacement of pump authorized under Permit No. 2768, 1958 - George N. Darrach). [Additional Reference(s): DWR Levee Log, 1993. USACE Sacramento O&M Manual, Unit 142 - Back Levee of Reclamation District No. 1001, June 1959, Revised 04 May 2018, 14-inch pipe (HLM 3.04)]. FS Date: 8/21/2019 12:56:00 PM

WS- an abandoned pipe on levee slope

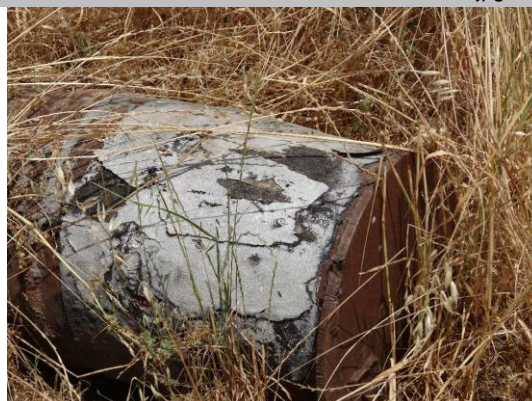
Photo 2 of 3 : UCIP_FA_2019_55204_23381.jpg

WS- an abandoned end capped pipe on levee slope

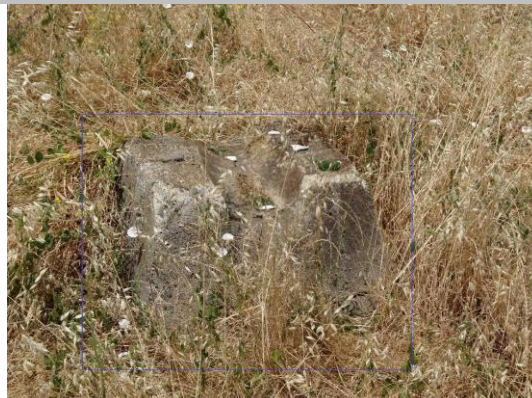
Photo 3 of 3 : UCIP_FA_2019_55204_23380.jpg

WS- concrete pipe support saddle.

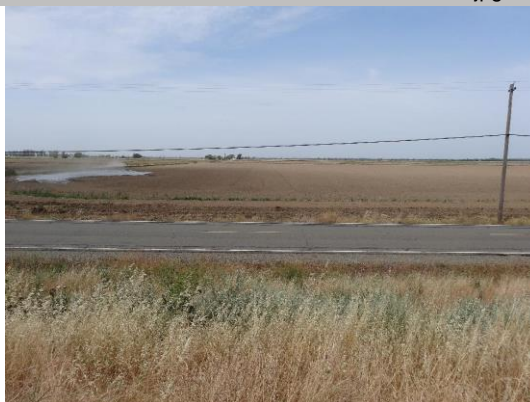
Photo 2 of 3 : UCIP_FA_2019_55205_23393.jpg

Comment Code					
Inspector Comment					
DS_ID:22637 FS_ID:55205 EP_NO: N/A Repair Type: Non-Urgent Crossing Status: Found UCIP Comments: 08/21/2019 Record has been updated from No Action Needed to Non-Urgent, no permit has been identified for pipe and due to limited inspection of pipe on the LS. Dense vegetation prevented a thorough inspection of LS slope for pipe damage. Record updated with USACE O&M reference. (O. Magana - DWR UCIP)05/15/2013 - no pipe and structure found on landside. (P. Amatya - DWR UCIP) FIELD_STRUCT_DESC: 24-inch corrugated metal gravity drainage pipe through the levee, 12 feet below the crown. Slide gate in a 36-inch corrugated metal pipe (CMP) riser on the waterside (WS) slope. Concrete collar on the WS edge of the berm. Concrete headwall at the landside (LS) toe. Pipe crosses under the channel. [Additional Reference(s): DWR Levee Log, 1993. USACE Sacramento O&M Manual, Unit 142 - Back Levee of Reclamation District No. 1001, June 1959, Revised 04 May 2018, 24-inch pipe (HLM 3.08)]. FS Date: 8/21/2019 12:56:00 PM

LS- no pipe/structure found on landside.

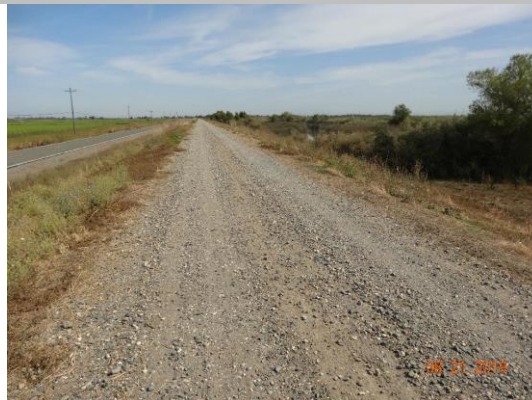
Photo 3 of 3 : UCIP_FA_2019_55205_81251.jpg

Overview of levee crown looking u/s towards pipe crossing.

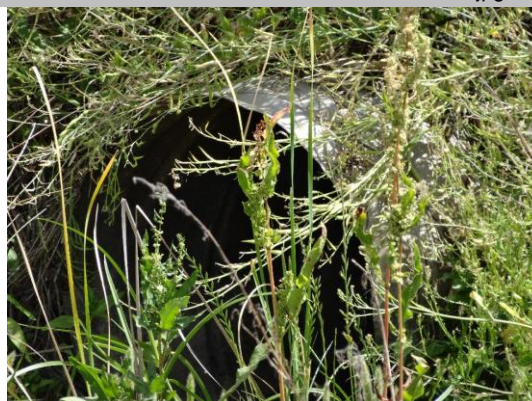
Photo 1 of 3 : UCIP_FA_2019_55206_23396.jpg

Comment Code						
Inspector Comment						
DS_ID:22630 FS_ID:55206 EP_NO: N/A Repair Type: Non-Urgent Crossing Status: Found UCIP Comments: 08/21/2019 Record remains Non-Urgent, no permit has been found and limited inspection prevented thorough inspection at crossing. Dense vegetation on LS slope and toe prevented a thorough inspection at pipe location. Record updated with USACE O&M reference. (O. Magana - DWR UCIP)05/15/2013 - pipe opens in irrigation ditch on landside.- vegetation cleaning on LS pipe opening. (P. Amatya - DWR UCIP) FIELD_STRUCT_DESC: 24-inch corrugated metal gravity drainage pipe through the levee, 12 feet below the crown. Slide gate in a 36-inch corrugated metal pipe (CMP) riser on the waterside (WS) slope. Concrete headwall at the landside (LS) toe. Pipe crosses under the channel. [Additional Reference(s): DWR Levee Log, 1993. USACE Sacramento O&M Manual, Unit 142 - Back Levee of Reclamation District No. 1001, June 1959, Revised 04 May 2018, 24-inch pipe (HLM 3.28)]. FS Date: 8/21/2019 12:56:00 PM

LS- vegetation on CMP end.

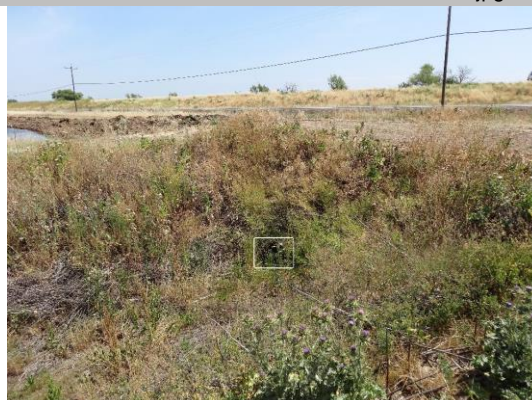
Photo 2 of 3 : UCIP_FA_2019_55206_23395.jpg

LS- CMP opens in irrigation ditch.

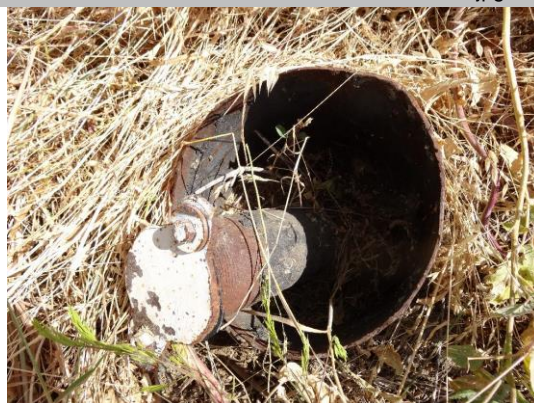
Photo 1 of 2 : UCIP_FA_2019_54565_22121.jpg

LM Start	3.43	Rating **	M	Issue No.	59
LM End	3.43	Issue Type +	En	Location *	
Category	Supplemental			GPS Latitude/Longitude	
				Start	End
Item	DRAFT DWR UCIP Field Study			38.879960 °	38.879960 °
				-121.524780 °	-121.524780 °
DWR ID	22619				
Comment Code					
Inspector Comment					
DS_ID:22619 FS_ID:54565 EP_NO: N/A Repair Type: Non-Urgent Crossing Status: Found UCIP Comments: 08/21/2019 Record remains Non-Urgent, no permit has been identified for pipe. (O. Magana - DWR UCIP)05/15/2013 - needs filling/plugging gap between 4-inch and 10-inch pipes. (P. Amatya - DWR UCIP) FIELD_STRUCT_DESC: 1 of 2: Capped 4-inch steel irrigation pipe sleeved through a 10-inch steel pipe, at an unknown depth. Pipe exposed just off the top of the waterside (WS) slope. [Additional Reference(s): DWR Levee Log, 1993]. FS Date: 8/21/2019 12:57:30 PM

WS- a 4-inch steel pipe sleeved through 10-inch steel pipe.
